# TECHNICAL ADVISORY BULLETIN

## Cleancut pump A2EA-6527

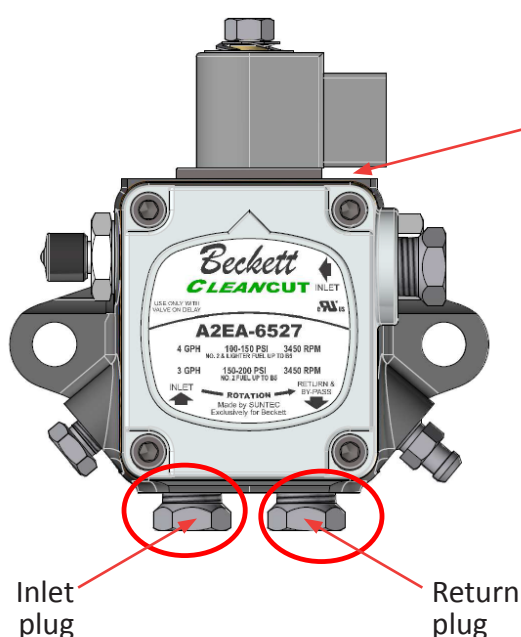
This bulletin advises that Cleancut pumps A2EA-6527 manufactured during months March, April and May 2016 might present a tightness issue on Inlet/Return 1/4-18 NPTF plugs.

In order to identify such pumps, it is necessary to check the date stamped on the top of the body :

Date code : **MMDDYY**  
(112216 = Nov. 22, 2016)

1. Before starting your burner, confirm the pump is not in the affected date range. If the unit is in the date range, follow steps 2 and 3.
2. Carefully verify the tightness of Inlet/Return plugs.
3. For any recognized or suspected leak, unscrew plugs and apply pipe sealant, and re-insert them with a fitting torque of 12 to 20 Ft.Lbs.
